AN EXPERIMENTAL STUDY ON PERFORMANCE OF REINFORCED CONCRETE COLUMNS WITH STRUCTURAL DEFICIENCY

Abstract

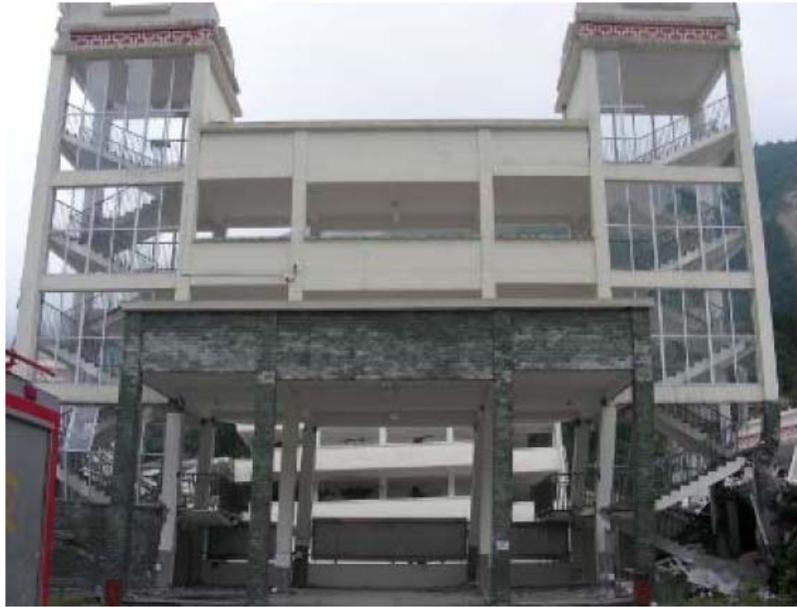
Figure 1. Slender columns and large permanent inelastic deformation (Wenchuan, China, 2008) [Source: RMS].

In many countries with high seismic activities, numerous RC frame structures exist that were designed and constructed conforming to earlier codes without seismic loads consideration. Many of the construction details used in the structures are now recognized to be associated with non-ductile failure modes when subjected to seismic excitement (Eshghi & Zanjanzadeh [3, 4]). As a result, they are vulnerable against moderate to severe earthquakes. In addition, due to poor construction practice and inspection in some countries, yet defective and flaw detailing has been implementing without meeting seismic demands. Furthermore, information gathered from past earthquakes demonstrates that there is a significant gap between requirements established by modern seismic codes and construction practices especially in rural areas. As a consequence, flaws in design, and/or construction practices can bring about same detailing deficiency, similar to ACI (pre-1971) provision, even in recently built structures. In addition to these flaws if these columns are slender, for example due to certain architectural intervention in the first floor to have higher ground story which can lead to soft story mechanism or sever damages as reported in past earthquakes (e.g., Figure 1), they will be more vulnerable, e.g., (Inel et al. [5]; Kaplan et al. [6]).

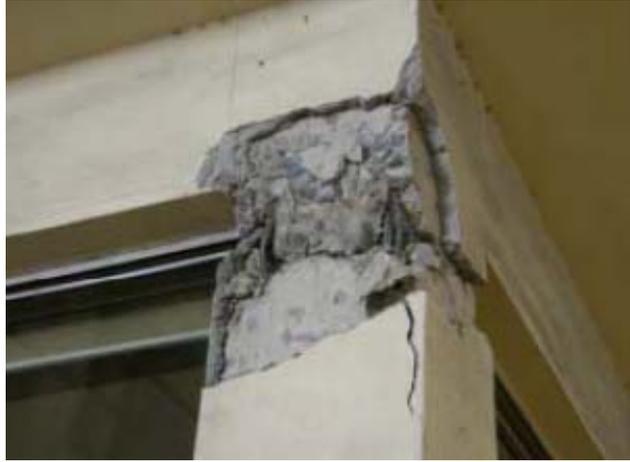
Figure 2. Damage in lap splice zone caused by absence of adequate confinement and improper splice (Bio-bio, Chili, 2010) [Source: RMS].

Figure 2 and Figure 3 show damaged two columns due to lap splice deficiency and lack of confinement in plastic hinge zone. Figure 3 reveals that such detailing deficiency can cause severe damage in a RC building. These observations from recent earthquakes also show that columns with such detailing deficiency still exist; therefore, understanding the behaviour of these columns is an important matter.

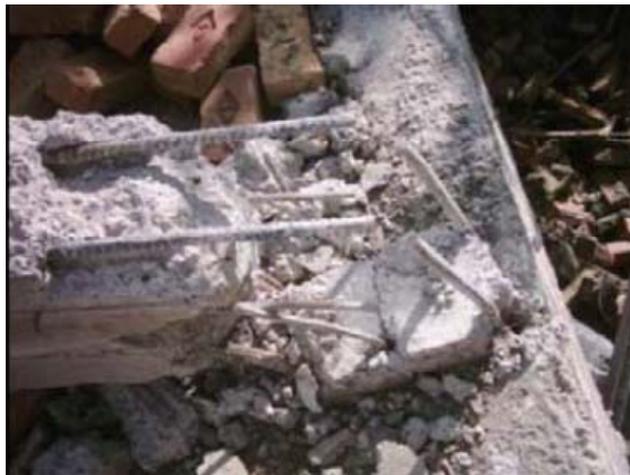
Figure 3. Collapsed RC column due to inadequate lap splice length and widely-spaced transverse bars (Kashmir, Pakistan, 2005) [Source: RMS].

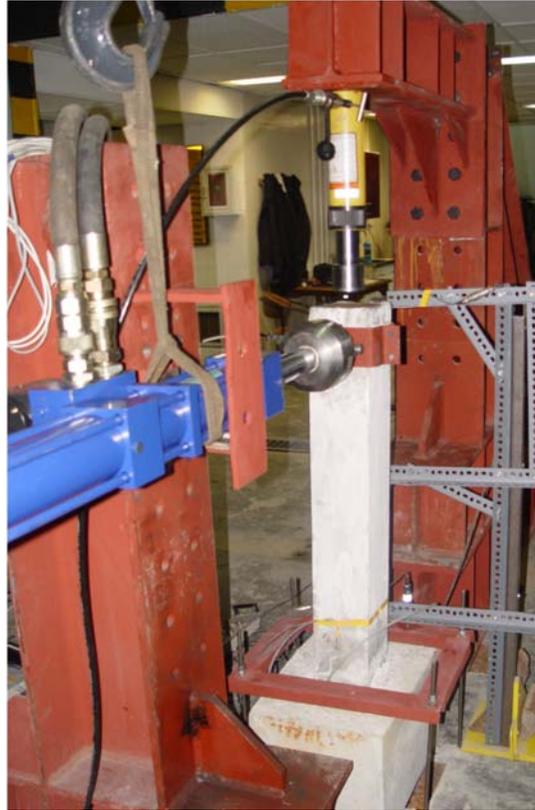
Figure 4. General view of the test set up.

The cantilever specimens were subjected to combined shear cyclic displacement and constant axial loading at top level as shown in Figure 4. Axial load was applied using a 100kN capacity hydraulic jack through hinges at the ends of the specimens allowing in-plane end rotations. During testing, the axial load was maintained constant by the hydraulic system. The reversed cyclic displacement was applied through a servo-controlled actuator having 60kN load and ± 60 mm stroke capacities. Displacement control mode of the actuator was used to apply the predetermined displacement history. Axial load levels were approximately 5%, 10%, and 15% of the assumed column gross axial capacity ($A_g f_c'$) for SP1, SP2, and SP3, respectively.

The lateral reverse cyclic displacement was imposed on each of the following peak drift ratios: 0.25%, 0.5%, 0.75%, 1%, 1.25%, 1.5%, 1.75%, 2.25%, 2.75%, 3.25%, 3.75%, 4.25%, 4.75%, 5.25%, and 5.75% as the displacement increments with two cycles at each level of drift ratio. As displayed in Figure 4, to provide cantilever-type loading condition, the bottom stub of the specimens was fixed to the base in order to achieve full fixity.

The longitudinal and transverse reinforcing bars and concrete of the specimens were instrumented with strain gauges to determine the steel and concrete strains at various locations and steps of the tests. Displacements were measured during testing by three linear variable differential transducers (LVDTs) (at the top, mid-height, and bottom of the columns), while the force response of the specimen was also continuously recorded. Also, two LVDTs were mounted on reaction wall and columns foundation to measure the possible uplift.

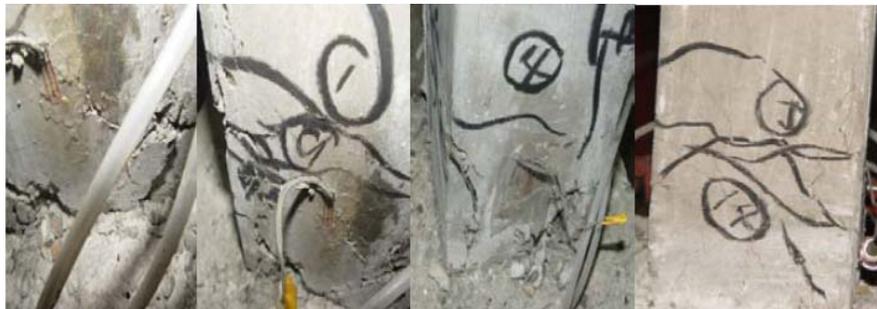
Figure 5. Failure modes and developed cracks of column specimens at end of the test.

The crack and failure patterns of each column at end of the test are shown in Figure 5. During testing of specimen SP-S1, initial flexural cracks were observed at the base of the column when displacement reached 1% of the drift ratio, and at 1.5% drift ratio at the end of the splice length. Some flexural cracks appeared along the splice during the test but the length and width of these cracks did not increase significantly.

Generally, similar damage was noticed in SP1, SP2, and SP3, that is, initially flexural cracking at the column-footing interface followed by horizontal cracks throughout the columns as the displacement increased. However, crack pattern changed to complex patterns thereafter including flexure, cover-concrete spalling, and shear cracks appearing near the ultimate load level. Cover spalling was an indication of splice failure in these columns (Melek & Wallace [9]). It seems that splitting bond failure induced cover-concrete spalling along the splice length in all these specimens. By increasing axial load the cracks appeared later and they were impulsive, and damage became more severe.
